# DAMAGE ASSESSMENT FORM

Building Name Redland Community Methodist Church

Address 24000 SW 187th AVE

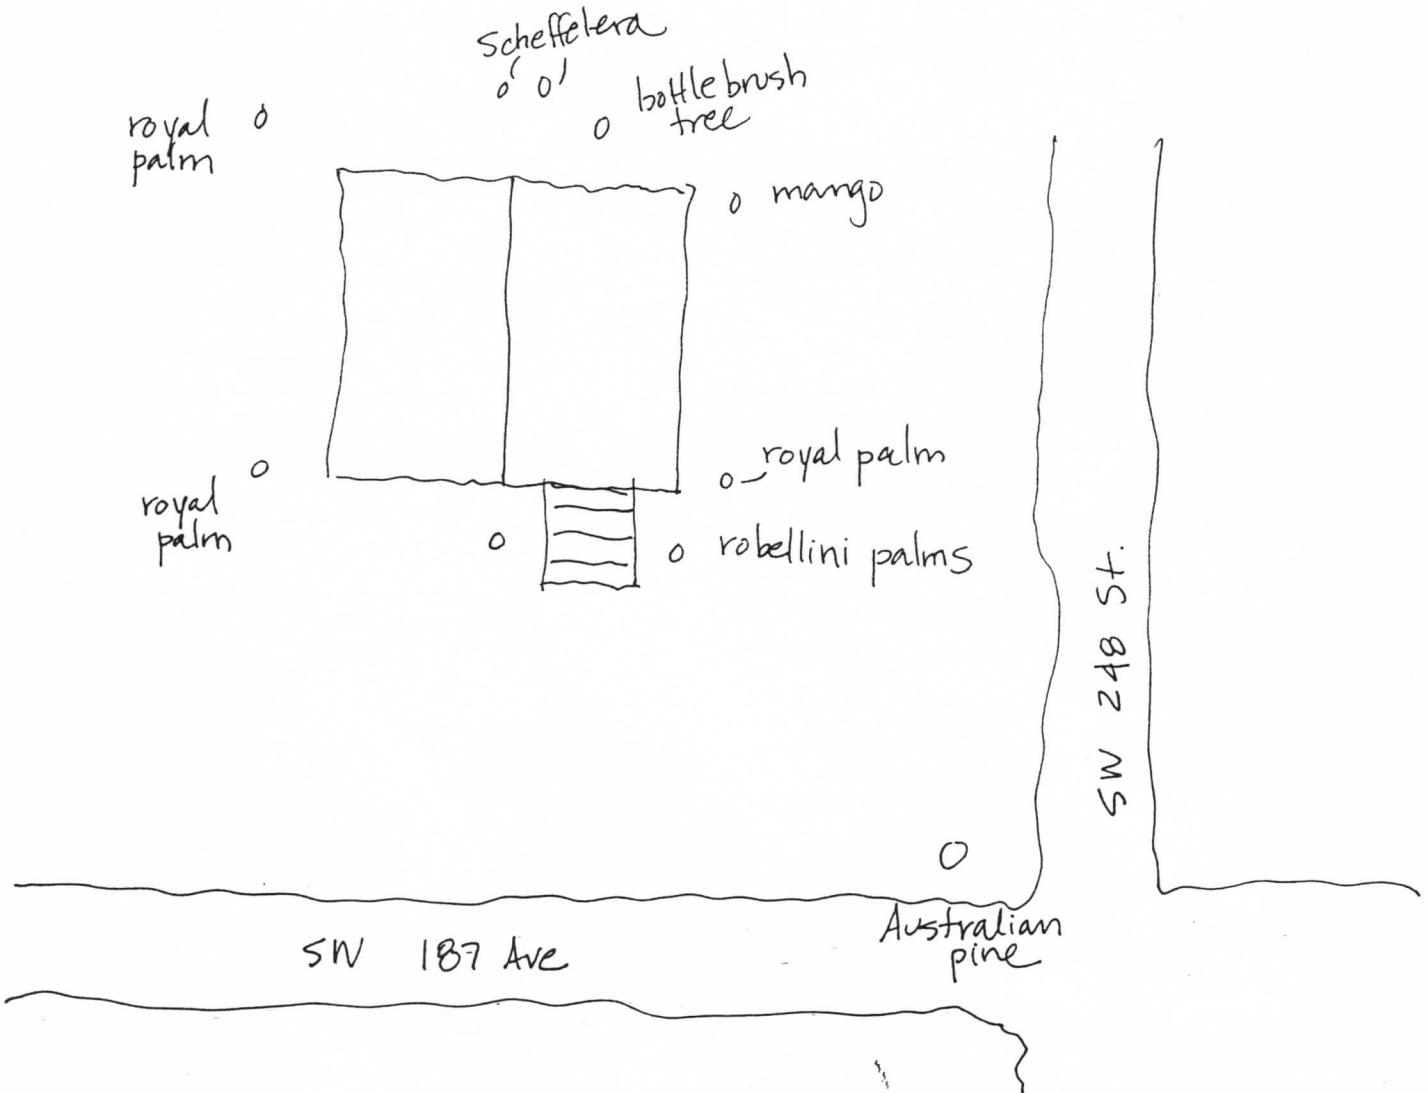
## Site Sketch:

- Comments:
- Most trees down
  - royal palms either missing top or down
  - robellini palms at entrance still standing
  - very few large trees on the site
